**A residential building in downtown Chicago was having repeated failures of their pumps with ECM motors. The LPD Mag, a high efficiency, low pressure drop Y-Strainer with a Neodymium Magnet, from the Metraflex Company, proved to be the perfect solution.**

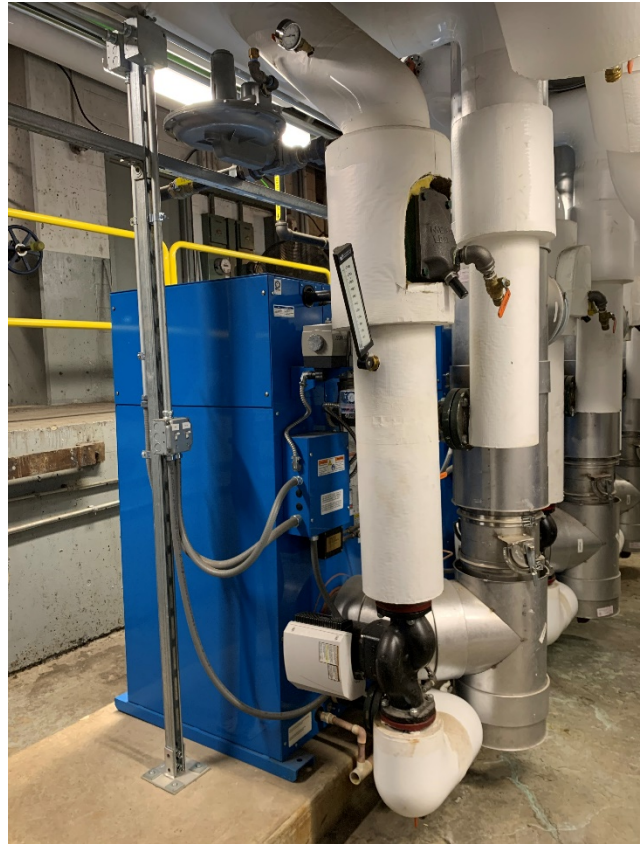
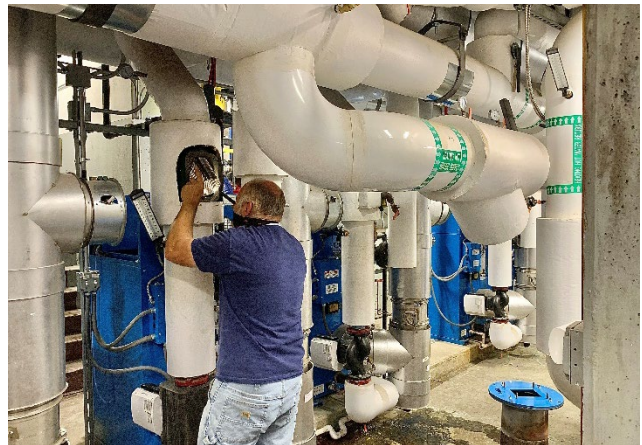
The LPD Mags were blown down in accordance with the instruction pamphlet that is provided with the product. The pumps were on and pressurized and 150° F, at 25 PSI. Following the instructions, the magnet was pulled halfway out, the valve was opened, then the remaining length of magnet was pulled out. This process pulls the metallic particles down into the blow off port, allowing for a clean blow out.

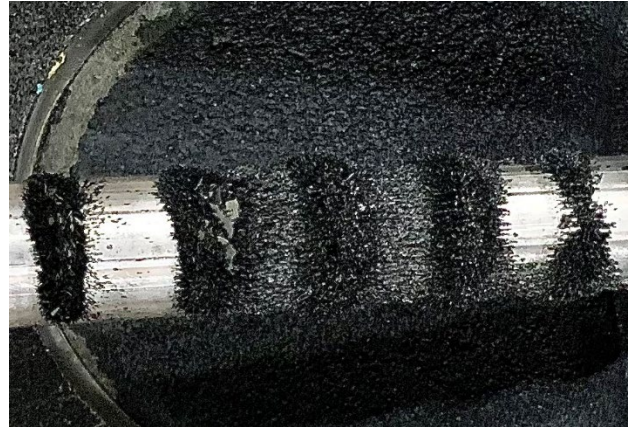
For the second strainer, the system was shut down and the cover plate was removed completely to get a sense of what is being attracted to the magnet (**Figure 1**).

After seeing the large accumulation of sludge/iron oxide that the magnet had attracted, it was time to re-install the cover plate and blow down the second strainer.

*Figure 1 The LPD Mag cover plate and attracted particulates shown before the blow down of the second LPD Mag Y Strainer*

Because this system already had 11 standard LPD Y-Strainers supplied by Metraflex, the solution seemed simple: The LPD Mag Retrofit Kit. Simply remove and replace the standard LPD cover plate with the retrofit cover plate that includes a dry well for the powerful Neodymium magnet.
