## CRV Flex and Pump Applications

## Pump Applications (continued)

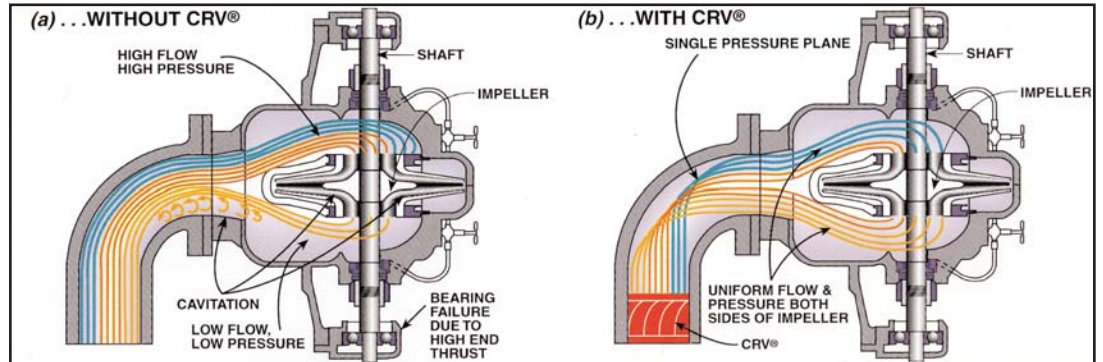
Figure 1 - top view of double-suction pump showing plain elbow (a) creates cavitation while a CRV® Flex (b) promotes an even fluid distribution.

With a double-suction pump tied to a close-coupled elbow, flow distribution to the impeller is poor and causes reliability and performance shortfalls. The elbow divides the flow unevenly with more channeled to the outside of the elbow as shown in Figure 1(a).

By imparting a swirl to the flow entering the elbow, the CRV Rotation-Vane enables the liquid to negotiate the turn and be evenly distributed to each side of the impeller, as shown in Figure 1(b). With the CRV, flow and head characteristics will approach factory rated pump test performance, cavitation and noise will diminish, and seal, bearing, and impeller life will improve.

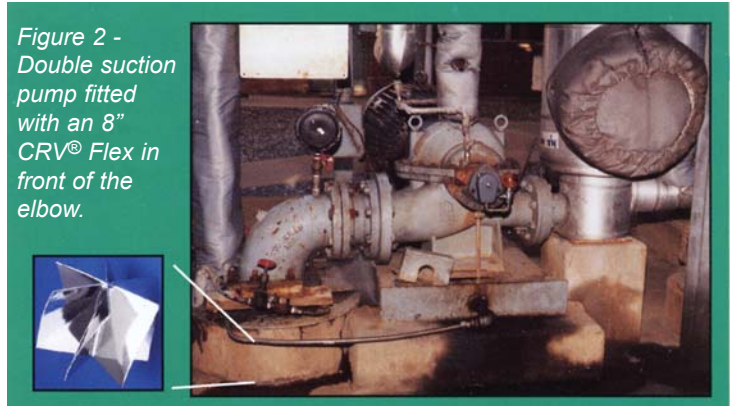
Figure 2 - Double suction pump fitted with an 8" CRV® Flex in front of the elbow.

As an example, one can consider the feed piping configuration of a 3,550 rpm double-suction pump utilizing an 8-inch CRV Rotation-Vane, as shown in Figure 2. Prior to installing the CRV, pump operation had been noisy and the unit required an overhaul every four months. A vibration spectrum of the

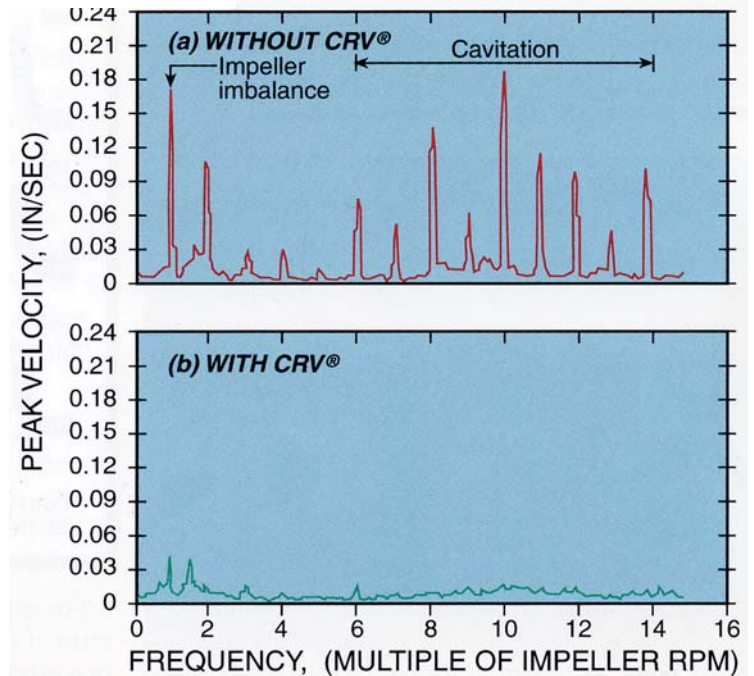
Figure 3 - Comparison vibration spectrum of 3,550 rpm double-suction pump with (b) and without (a) a CRV® Flex.

pump just prior to CRV installation is shown in Figure 3(a) and just after CRV installation is shown in Figure 3(b). The dramatic reduction in measured cavitation (6-14 range on frequency scale) also resulted in a reduction in impeller imbalance (1 on frequency scale), which reduced noise, extended seal, bearing, and impeller life, and increased delivered head and flow. Prior to CRV installation, three identical pumps in parallel operation were required to deliver the required flow rate. After the CRV was installed on each pump, two pumps met the flow rate requirement and the third pump serves as an installed spare.

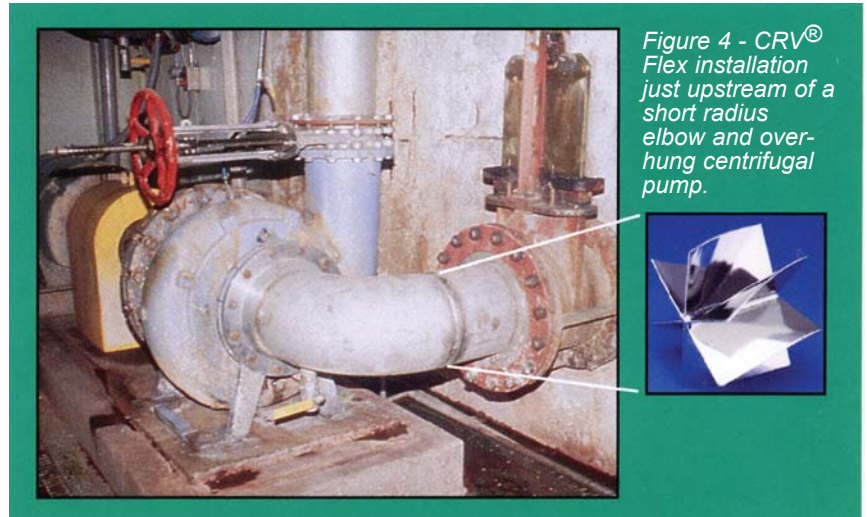
Figure 4 - CRV® Flex installation just upstream of a short radius elbow and overhung centrifugal pump.

With overhung centrifugal pumps, the same performance and maintenance improvements can be realized by the use of a CRV Rotation-Vane. Figure 4 shows an overhung centrifugal pump which required a complete rebuild every six months. After installing the CRV, the pump has been operating for 11/2 years without a pump rebuild.
