Suction Diffuser Vanes for Pump Applications

Pump Applications (continued)

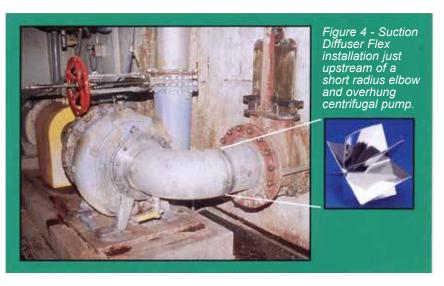
Performance and maintenance improvements can be achieved with overhung end-suction centrifugal pumps too. Figure 4 shows an end-suction centrifugal pump which required a complete

rebuild every six months. After installing the Suction Diffuser Vane, the pump has been operating for 1-1/2 years without a rebuild.

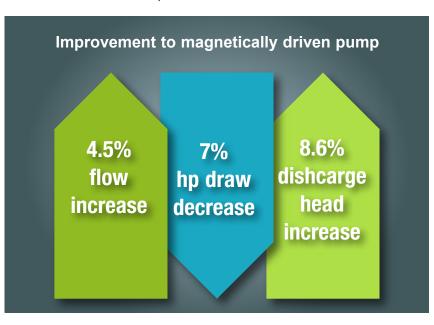
increased 4-1/2% from 1086 gpm to 1135 gpm after the Suction Diffuser Vanes were installed. At the same time, the

horsepower draw dropped 7% from 43 to 40 and the discharge head increased 8.6% from 81 to 88 ft. The key benefit, however, was the reduced vibration which eliminated a frequent repair cost of \$5000 on the shaft and bearings as well as an occasional severe-failure repair cost of \$14,000 per occurrence.
